SHEAR MECHANISM FOR MINING-INDUCED FRACTURES
APPLIED TO ROCK MECHANICS OF COAL MINES

Brian G. White

Spokane Research Laboratory, National Institute for Occupational Safety and Health, Spokane, WA, USA

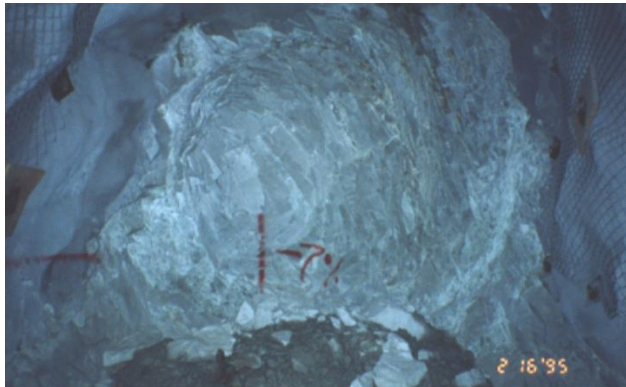
Figure 1. Cavity created by a face-strain rock burst in a development heading of a hard-rock mine.

A rock burst in an Idaho silver mine took place in the face of a development heading that was being driven normal to vertically dipping, massive quartzite beds (figure 1), creating a bowl-shaped cavity centered in the face. Inspection showed that the quartzite had been thinly split on the edges of the cavity (figure 2), but much of the broken rock ejected from the cavity was thicker than the quartzite at the edge of the cavity. Inspection of the walls after the next advance showed no evidence of splitting. Thus, the splitting was confined to the edge of the cavity and evidently represented

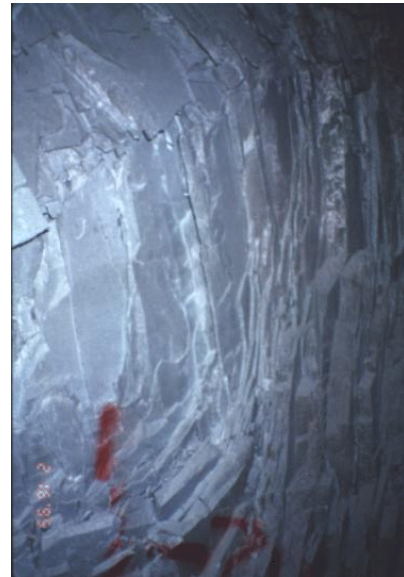
Figure 2. Edge of burst cavity shown in Figure 1. Note closely spaced fractures.

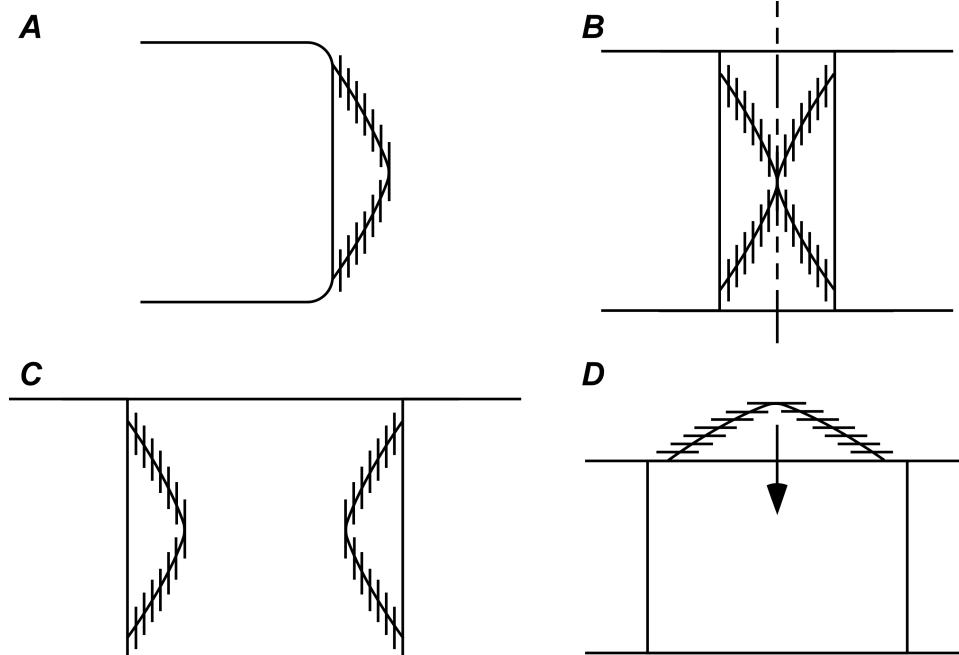
Figure 3. Cross sections of fracture zones in various settings. *A*, Cross section of face-strain burst shown in figures 1 and 2; *B*, compression test specimen; *C*, hour-glassing of pillars; *D*, inverted-V failure of entry roof.

many individual fractures that were progressively offset with depth along the cavity edge toward the center of the face (figure 3*A*). This contrasts with a classic view presented by Fairhurst and Cook (*1*) that mining-induced fractures extend all the way across a face or surface.

A cross section through the face (figure 3*A*) showed that the fracture distribution bore a striking resemblance to fractures formed in laboratory tests when the ends of the samples are constrained

against expansion or slippage and en echelon fracture zones extend obliquely from opposite corners (figure 3*B*). Thus, the rock burst seemed to be a good field example of the laboratory test. The fractures in the laboratory specimens also resembled the fractures that cause hour-glassing in pillars (figure 3*C*) (*1*).

mudstone roof occasionally experienced inverted-V-type roof failures. The geometry described by mine personnel (figure 3D) suggested that the edges of these cavities were also formed of closely spaced bedding plane separations systematically distributed along what would eventually become the edge of the collapse.

A second example of familiar mining-induced fractures in coal mines involves those that form parallel to bedding in entry roofs. One example has already been mentioned earlier, in which fracture zones inclined upward from both sides are associated with inverted-V-type roof failures (figure 3D). Inverted-V fracture zones obviously require equal horizontal stresses at each corner (figure 9A). But, if the major principal stress is inclined with respect to the opening, one corner is shielded from this stress. Fractures will only develop preferentially from the opposite corner and may also extend higher above the back along a steeper plane (figure 9B). An inverted mirror image of this zone may also form in the floor (figure 9B), but this paper only considers the roof.

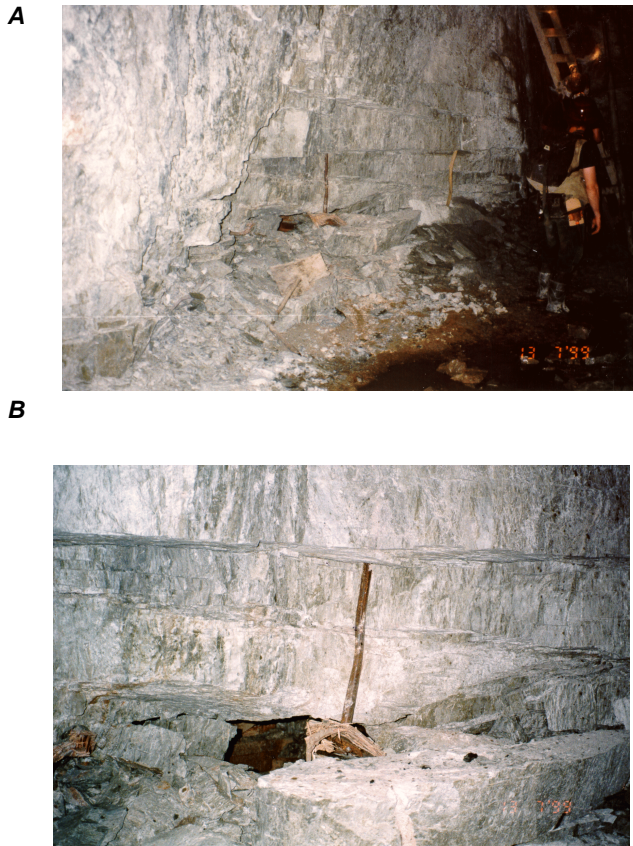
Figure 4. Cut (or drift) in a steeply dipping hard-rock vein. A, View along wall. Photo taken while standing on sandfill from previous cut. Note mining-induced fractures and temporary friction rock bolts from roof of previous cut exposed in wall. B, View of wall showing bent rock bolt offset by shear displacement along an echelon fracture zone.

This example (figure 4) is in a steeply dipping, narrow vein. The vein is mined by the overhand method, which involves mining the vein in a horizontal cut or drift, filling the cut with sand, and then driving a new cut on top of the sand. Thus, mining advances along a longwall front in an ore body that stands on end.

Split-Set¹ rock bolts provide temporary support during the mining of each cut. Since the vein was not quite vertical, each cut was slightly offset from the one preceding, so that bolts installed in the roof of the previous cut were sometimes exposed in the next cut above (figure 4). High stress around the ends of the mined portion created horizontal fractures that became exposed in the walls and face of each new cut (figure 4B). In figure 4B, a rock bolt from the previous cut intersects fractures that were induced by mining, as shown by shearing offset of the bolt. It is also evident that the fractures involved are not continuous, but form a zone of systematically offset, or en echelon, fractures. Such fracture zones have been found to be common in the deep hard rock mines of Idaho.

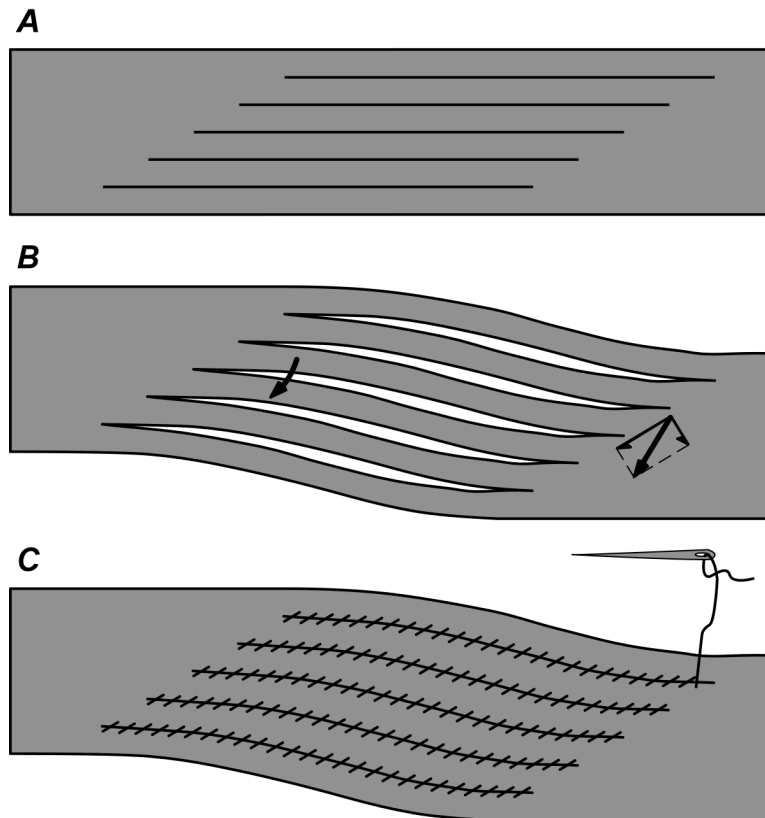
Figure 5. Displacement mechanics along en echelon fractures. A, En echelon fractures with intervening layers; B, combined dilation and shear displacement resulting from rock layers rotating away from adjacent substrates; C, fractures zone “repaired” with imaginary needle and thread. Both stitches and layers are under tension, thereby illustrating the origin of the tensile stress that causes fractures.

The observation that the fracture zone experienced shear is consistent with the fractures having resulted from high horizontal stress. Shearing effectively reduced the magnitude of the stress. The mechanics of shearing evidently involve bending of the rock layers (figure 5). Bending, in turn, causes dilation as the end of each layer is lifted away from its substrate. Hence, it may be concluded that the stress that causes the fractures is reduced at the expense of shearing and dilation, with a net displacement that is oblique to the fracture zone. However, extensive shear displacement only occurs after fractures have formed. Therefore, the fracture zone must actually result from shear displacement that originates prior to fracturing, when conditions are still elastic. There appears to be no alternative to this interpretation.

The simplest illustration of this idea can be seen when a reference shape, such as a square, is deformed into a parallelogram by shearing along two opposite sides. The diagonal distance between opposed acute corners increases and represents extension. Near mine openings, the extension becomes tension. Alternatively (figure 5C), we can imagine “repairing” the open fractures of Figure 5B with an imaginary needle and thread. If so, it is evident that both thread and rock layers are in tension.

Along originally straight edges of mine openings, the fundamental shape is a flattened S (figure 5B, C). The direction of greatest stress crosses the S at a low angle, so a fracture that forms parallel to the opening actually experiences a little bit of shear

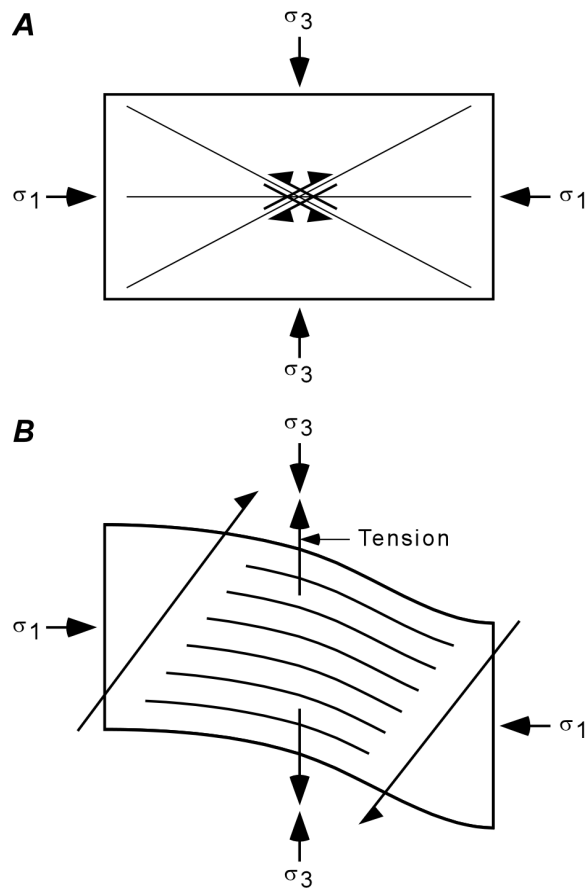
Figure 6. Contrasting views of fracture formation. A, Conventional view that principal stresses cause either conjugate faults or extension fractures parallel to greatest principal stress (σ_1) through compressive stress alone. B, Alternative view as expressed in this paper, that extension fractures, the most common mining-induced fracture type seen in hard-rock mines, result from elastic shearing displacement that generates tension approximately parallel to the direction of least stress. (Note: Distortion is highly exaggerated.)

This explanation for mining-induced fractures contrasts with the prevailing view that such fractures form parallel to the direction of greatest stress as a result of this stress alone (figure 6A). The explanation advocated here is that the fractures result from shear strain caused by load and by distortion resulting from the presence of a nearby mine opening. In general, this distortion happens at corners or edges of mine openings because the openings create a preferred direction of displacement that takes the form of shear (figure 6B). The shear, in turn, generates diagonal tension approximately parallel to the direction of least stress, and extension fractures result.

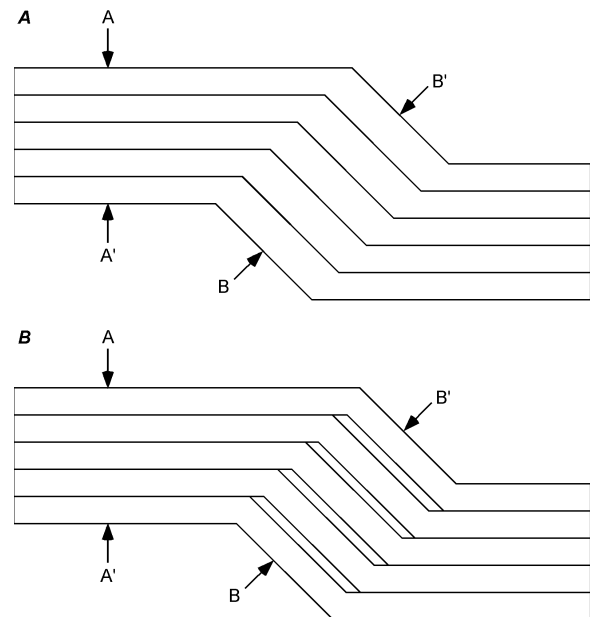
Figure 7. Representation of kink band, a familiar geologic structure. A, Dimension B-B' is increased with relative to original thickness A-A'. B, Geometry of deformation reduces high interlayer friction by separating layers within band, thus enabling deformation to take place.

One way of looking at fractures that is especially relevant for roof rock in coal mines is by comparing them to the geologic structures known as kink bands (figure 7). Empirically, kink bands form in layers that possess high interlayer friction (3). A kink band solves the friction problem by dilating the layers within the kink band. The dilation is a simple consequence of the geometry, the dimension normal to the layers increasing within—as compared to outside—the band, so that the layers separate enough to reduce or eliminate friction. In a similarly deformed, unlayered material, the

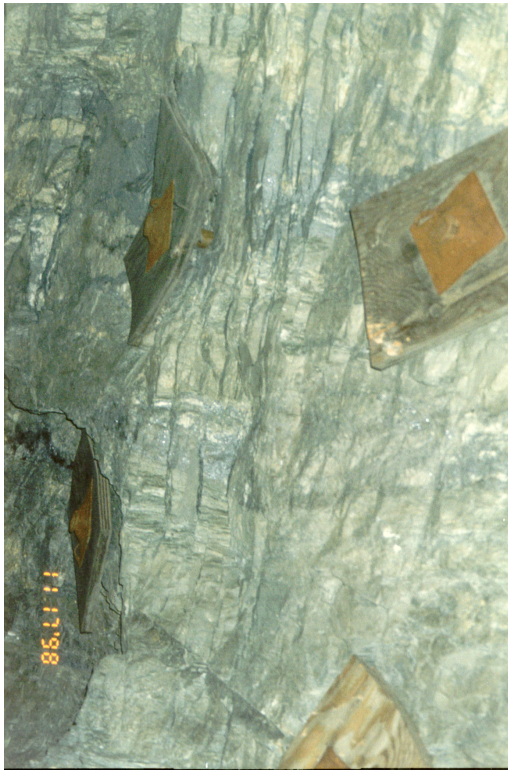
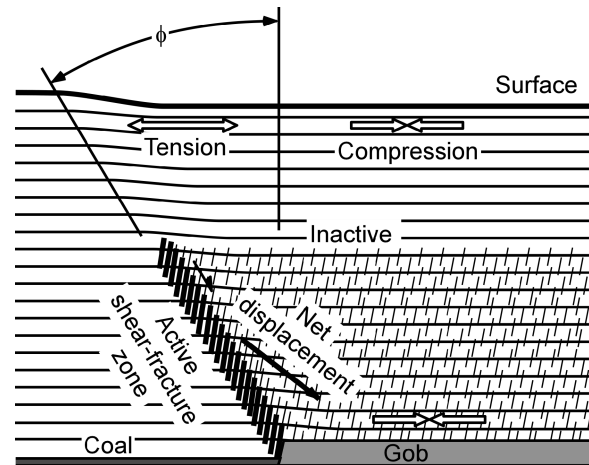
Figure 8. Mining-induced fractures parallel to the face in longwall mines. A, Hard-rock mine, vertical vein (photo rotated 90° to approximate geometry of flat-dipping coal); B, proposed origin of fractures in coal mines as result of shear displacement along angle of draw.

A familiar fracture type seen in longwall coal mines, as well as in South African longwall gold mines and Idaho silver mines, is one that forms parallel to the face. This type is instrumental to cave development (figure 8). These fractures apparently form in the region of high, nearly vertical stress that is concentrated ahead of the face (figure 8B).

Longwall mines are also characterized by subsidence that extends beyond the face a distance partially defined by the draw angle ϕ (figure 8B). In addition, horizontal stress changes associated with subsidence increase compressive stress over the longwall panel and create tension adjacent to the edge of the draw (4).

The opportunities for shear as a result of the high vertical stress near the face are limited. A direction describing gravitationally assisted movement toward the gob is strongly favored. Thus, a preferred direction of shearing extends upward along the angle of draw. As the face advances, the fractures are pressed closed along the upper edge of the active shear zone and opened below.

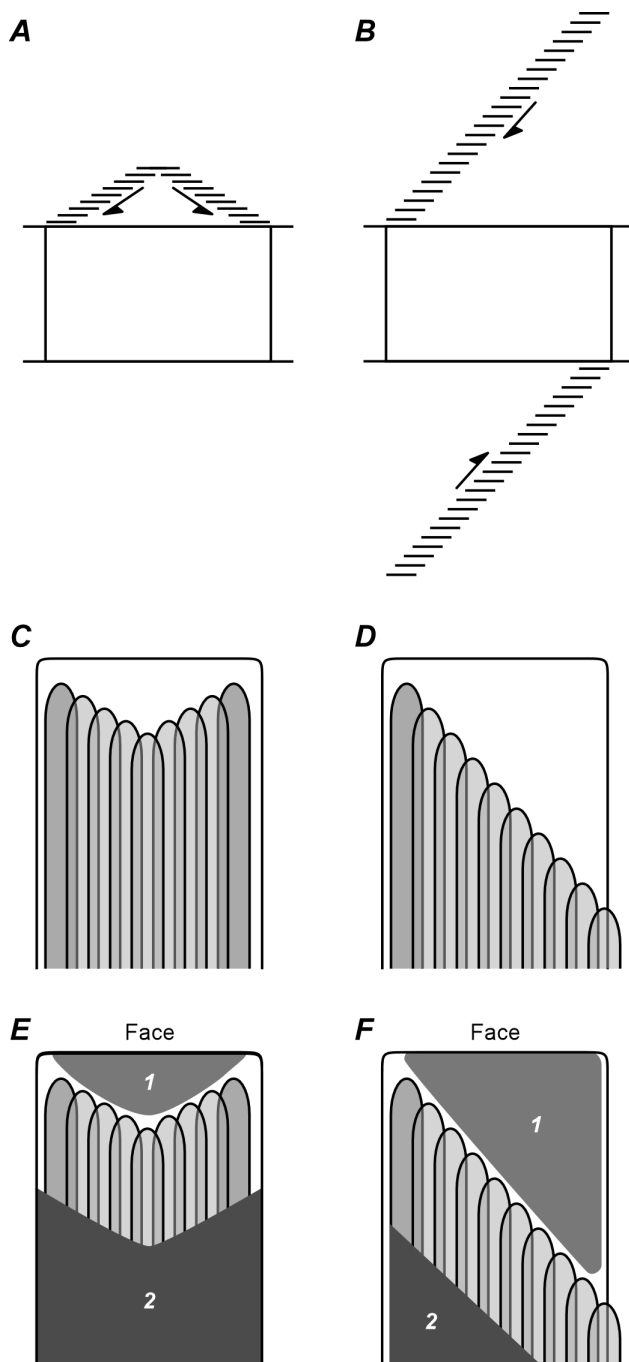
Figure 9. Fracture zones in entry roofs. A, Horizontal stress produces symmetrical fracture zones. B, High subhorizontal stress generates asymmetrical fracture zones that are steeper and extend deeper than fracture zones shown in A. C, Plan view of A in which fractures are viewed through roof. D, Plan view showing fractures in B. E, F, Roof bolts installed in area 1 are subjected to dilation and shearing as fracture zone follows face advance; bolts installed in area 2 are in ground where fracture zone is already well developed.

Both of these situations can be illustrated in plan view (figure 9C, D). The fractures and fracture zones are fully developed some distance from the face, while fractures near the face are limited. As a practical concern, rock bolts installed away from the face are inserted through already fractured, sheared, and dilated ground. These bolts are doing the job they do best: They are subjected to tensile load and experiencing only minimal stress, so the roof is likely to be stable providing anchorage is adequate. But bolts installed close to the face in unfractured ground will be subjected to shearing and dilation as soon as the face advances and the fracture zone progresses.

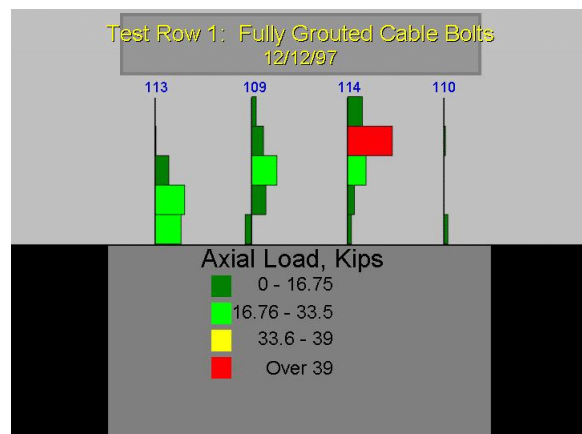
Figure 10. Cross section through instrumented roof bolts installed near entry face (after 5). Bolts loaded rapidly along a sloping line with subsequent entry advance. Bolt failures progressed downward to the left until total collapse.

A good example of progressive bolt loading that can be accounted for by this mechanism has been documented by Signer and Lewis (4) (figure 10). Instrumented bolts installed in the roof near the face recorded a buildup of load that progressed downward from high on one side of the roof. Ultimately, loads exceeded the capacity of the bolts, which failed progressively (deepest failure first) until a cave resulted.
